CONSTRUCTIONAL ASPECTS OF PRESSURE SHAFTS AT TEESTA-V PROJECT

B.K. Ojha
Ex-Chief Engineer (NHPC)

Abstract: This paper deals with constructional aspects and the problems encountered during excavation of the three pressure shafts of Teesta-V project. The pilot shaft excavation earlier planned with Raise boring machine could not be done and was alternatively executed by a combination of conventional Sinking method and Alimak Raise climber because of poor geological condition of the rock medium. The paper also summarizes the fabrication and erection aspects of steel liner.

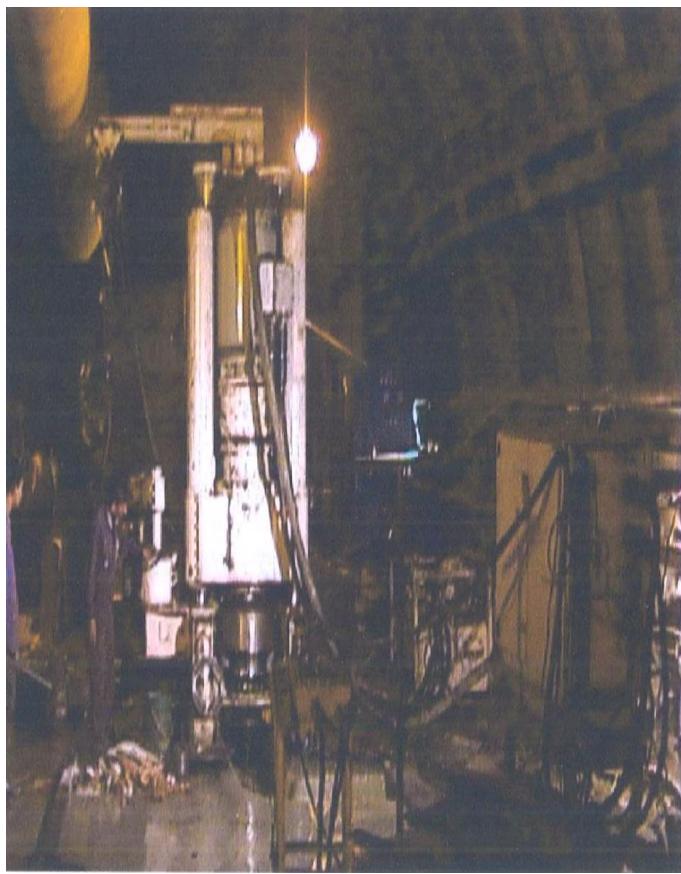
The erection of steel liner was planned through a 62 M (L) 12 M (W) X 10 M (H) penstock erection gallery (PEG) having invert at EL 542.0 M. Three vertical shafts were excavated to join the top horizontal portion of the penstocks at its bend location at EL 525 M. The three Shafts with excavation diameter of 6.3 M was planned for excavation with Raise Boring Machine. This involved boring a pilot hole of 280 mm dia and then reaming it to 1800 mm dia. Thereafter the excavation was to be done by conventional drilling and blasting from top to bottom and mucking to be carried out from bottom by dropping/falling the excavated material through Pilot shaft. The details of Raise boring machine used for the work are:-

Name of Machine Robbins Raise Drill (Overhauled and reconditioned) Model No. 61R

Dia of Pilot Bit 280mm

Dia of reamer Bit 1800mm
